# **Defense Infrastructure**

General and Flag Officer Quarters at Pearl Harbor, Hawaii (D-2002-125)

SUBJECT: Report on General and Flag Officer Quarters at Pearl Harbor, Hawaii (Report No. D-2002-125)

**Report No. D-2002-125**

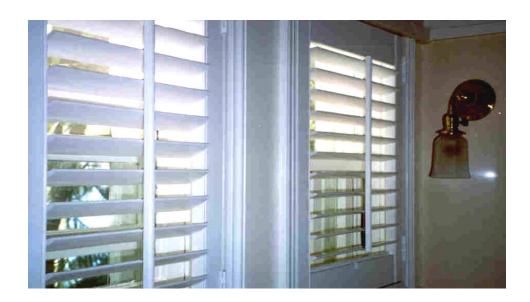
Area rugs are classified as furnishings because they are moveable, while wall-to-wall carpeting is attached to the floor and is classified as M&R. The NAVFAC counsel comparison of interior shutters to draperies and curtains is tenuous because interior shutters are permanently attached to the housing unit while draperies and curtains are not. Further, the installation of interior shutters is fundamentally the same as interior doors because nails, hinges, and screws are used to secure both to the building. The interior shutters in question were made from polymer, which was inconsistent with the state historic preservation office's requirements, and custom cut, then nailed or screwed to the window molding, caulked, and painted. The following picture illustrates the interior shutters installed in GFOQs at Pearl Harbor, Hawaii.
